January 12, 2016

**Re: Warren Steel Holdings
Notice of Violation (NOV)
NOV
RCRA C - Hazardous Waste
Mahoning County
OHR000007773**

Subject: Complaint Investigation and LQG CEI NOV

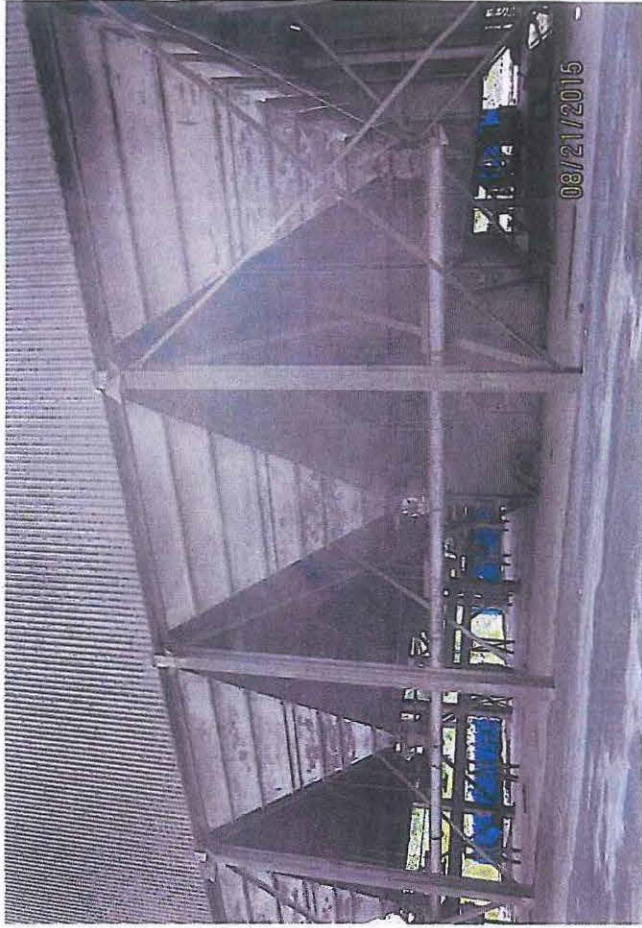
6978 – North side of baghouse looking toward SE
6979 – Area to NE of baghouse and south of old melt shop, "oil resting place", ~20-30 drums and ~30 totes, some empty, mostly used oil, one labeled "acid water", also see #6087 for overview, black stained soil, apparent used oil release
6980 – Released oil on ground
6981 – Drums in poor condition, black grease or oil on top and on ground, area to NE of baghouse
6982 – Stained ground in area to NE of baghouse
6983 – More stained ground in area to NE of baghouse near a drum labeled 'used oil'
6984 – Drums in area NE of baghouse
6985 – Open drums with what appeared to be a grease substance
6986 – Ditto
6987 – Overview of area NE of baghouse, "oil resting place", at center looking toward the east
6988 – Overview of "oil resting place", at center looking to the west
6989 – Center of "oil resting place" looking north
6990 – Tote labeled "used transformer oil"
